METEOR

Modelling Exposure Through Earth Observation Routines

Tanzania Scenario Walkthrough

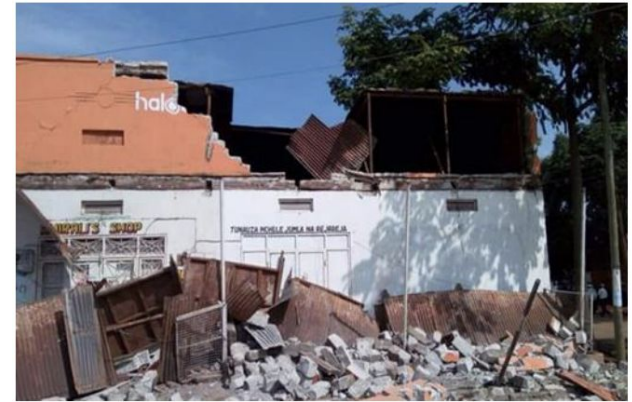
A collapsed building in Bukoba town, following the earthquake. Source: TRCS

Residents were fearful to re-enter their homes due to visible damage and cracks

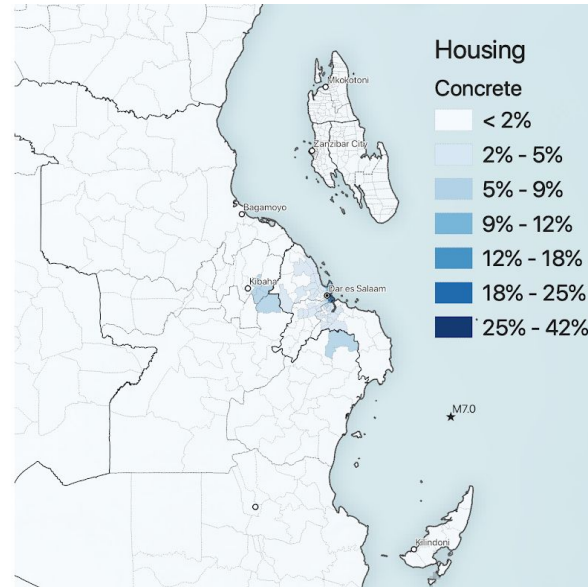
Different construction types are more likely to exhibit damage in the case of earthquakes. For example, masonry tends to become more heavily damaged than concrete or wood construction.

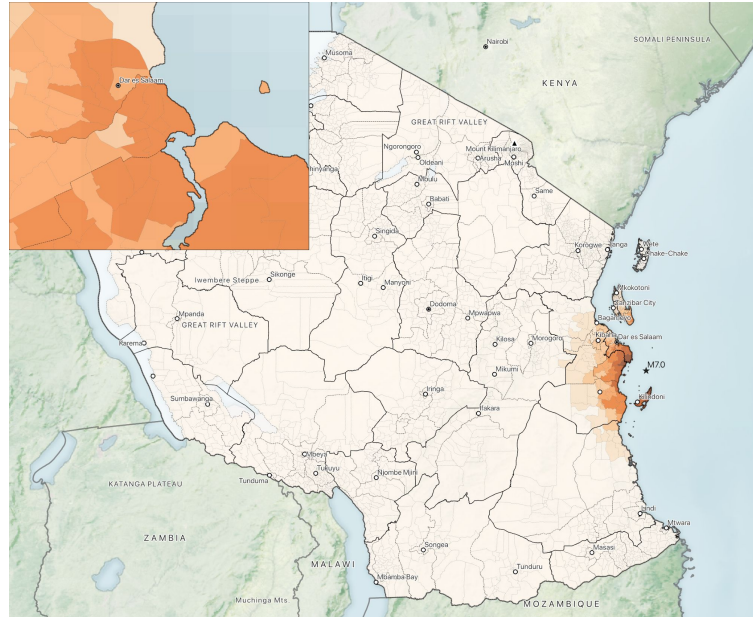
Damaged residences	Destroyed residences	Most affected district
Dar es Salaam	270,000 (21%)	5,200 (0.4%)	Temeke
Pwani	39,000 (15%)	830 (0.3%)	Mafia Island
Zanzibar	11,900 (7%)	80 (<0.1%)	Kati

Low-rise masonry buildings disproportionately damaged relative to other construction types within the affected region
